**Coal Combustion Residue Impoundment  
Round 9 - Dam Assessment Report**

***Oklahoma Power Station***

***Wastewater Evaporation Pond 6 – WMU 001***  
***American Electric Power***  
**Vernon, Texas**

**January 2012**

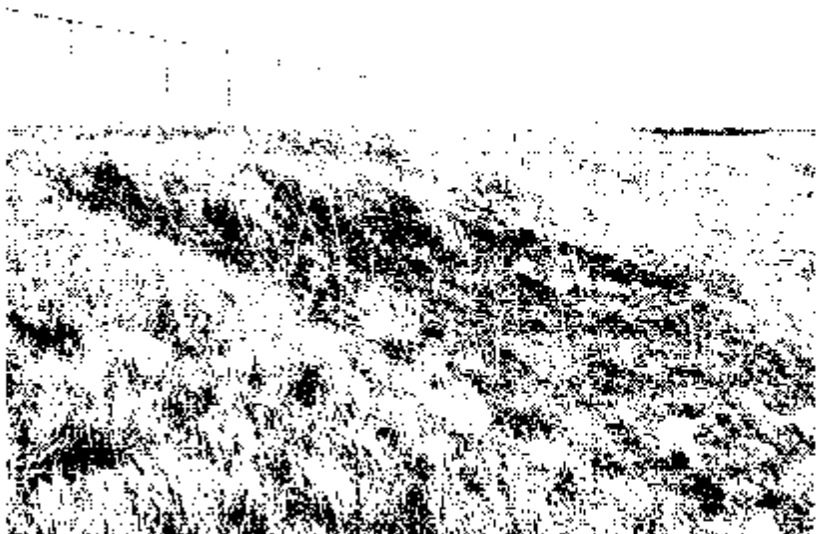
West downstream slope on southern end of Wastewater Evaporation Pond #8. Notice erosion gullies.	
Photo # 9

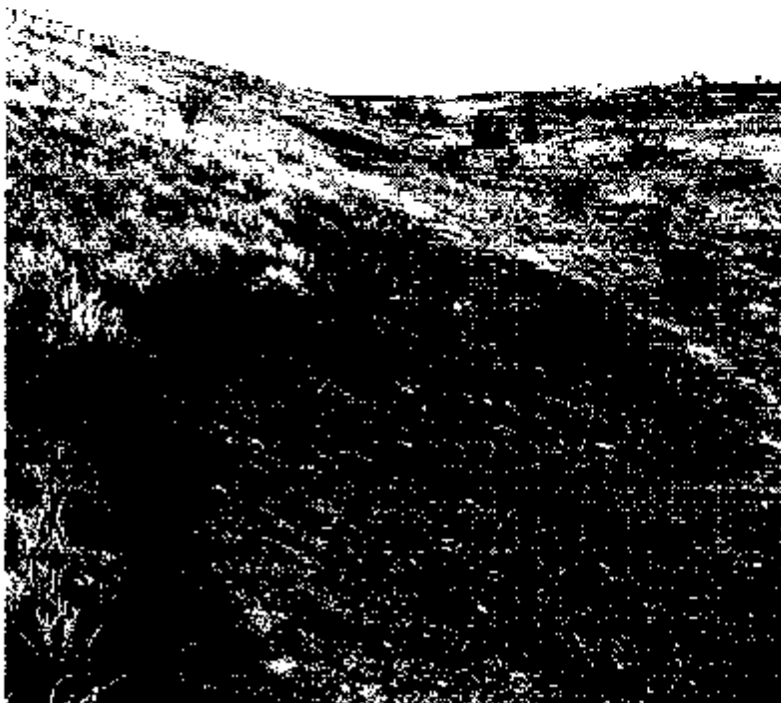
Photo # 13

Erosion scarp on west  
embankment at northern  
end of Pond #8.

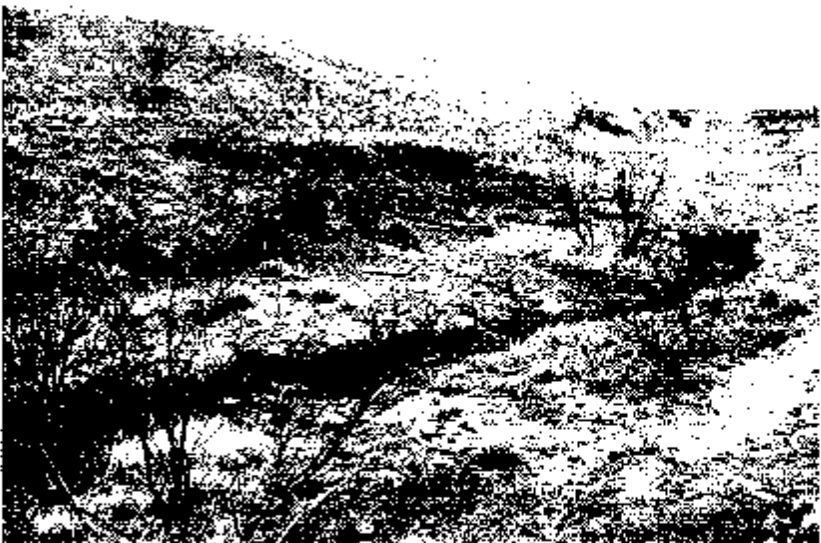
Erosion channel at northern toe of embankment for Pond #8.

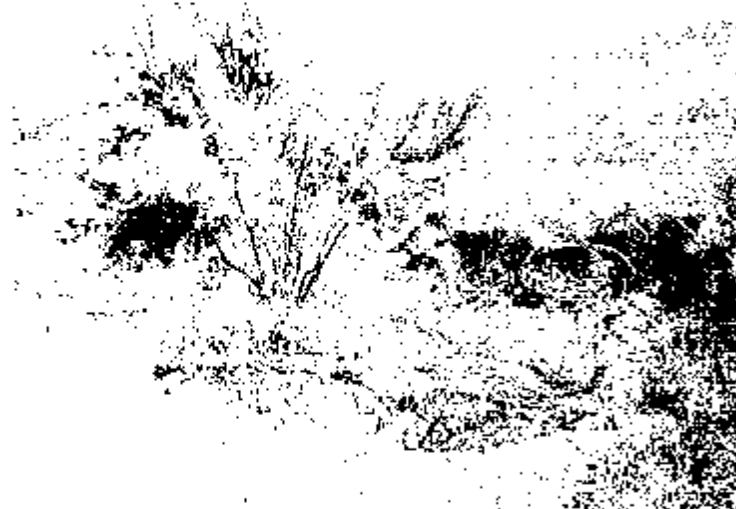
**Photo 18**

The downstream slope was in generally fair condition. There were no observed signs of slope failure, slumping, or seepage on the slope. Vegetative cover ranged from fair to poor with very similar features along the central and southern portions of the slope as those noted for the downstream slope at Pond #6 (recent seeding but dead emergent grasses and live weeds 2 to 3 feet in height). A typical view of the southern portion of the slope is provided in Photo 16. Along the northern portion of the slope, erosion rills have begun to develop in a sparsely vegetated area as shown in Photo 17. An area of significant erosion at the toe of the slope due to stormwater runoff was observed at the northern end of the pond as shown in Photo 18. This could eventually lead to stability concerns if left unaddressed.

Significant erosion cutting at the toe of the north end of the downstream slope at Pond #8.

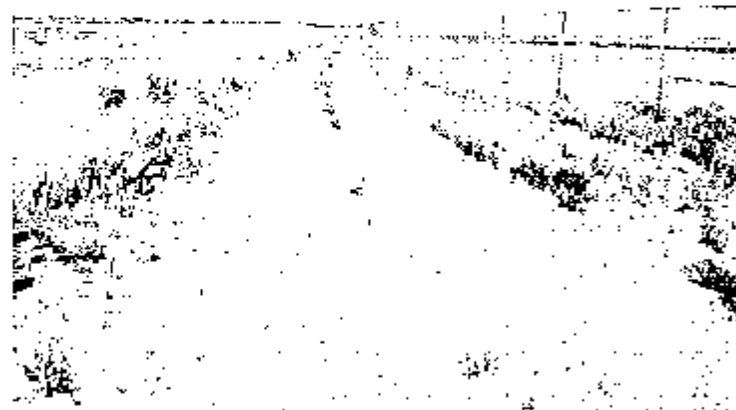
**Photo 21**

Pond #10 is located at the southwest corner of the main evaporation pond complex area. The upstream slope of this embankment is covered with an HDPE liner and was not directly observable. No undulations, bulges, depressions, or undue stresses on the liner were observed. The crest of the embankment appeared to be in fair condition with no unusual cracking, rutting, settlement, deformation, or misalignment. However, at this location the crest has no surface cover of gravel to provide protection from rutting due to vehicular traffic and there is very little, if any, access to the area by vehicle during inclement weather conditions because of the slippery road surface. A view of the crest from the southwest corner of the pond, looking north is provided in Photo 21.

View of crest of western dike from southwest corner of Pond #10 looking north. The crest along the west side of Ponds #8, #9, and #10 has no surface cover of gravel.

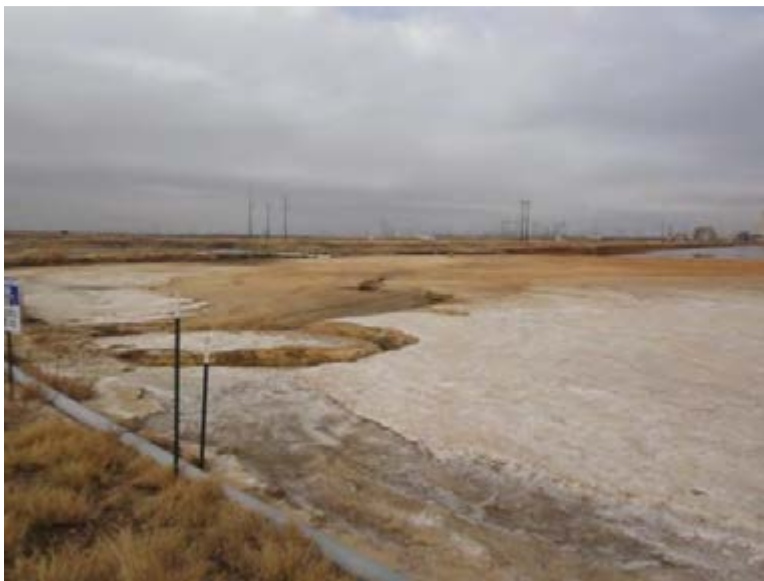
Figure C-3. Additional incised CCR pond #23

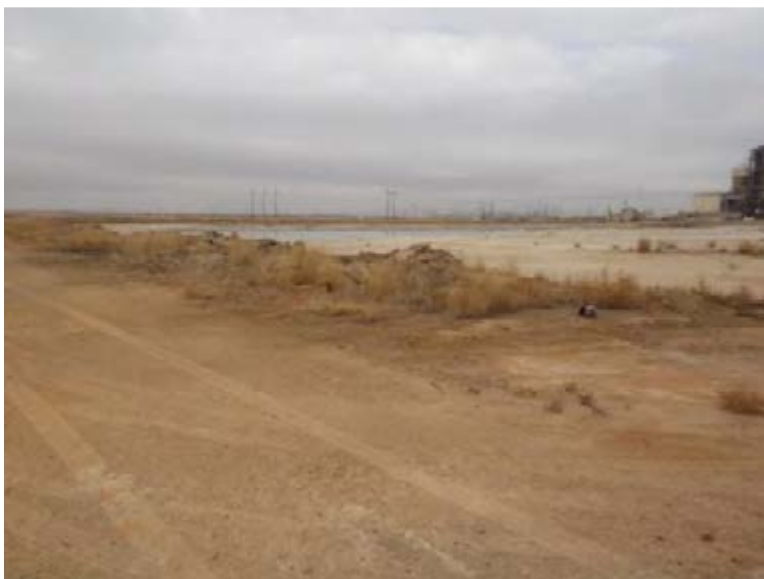
Figure C-4. Additional incised CCR pond #7
